SPOTLIGHT SURVEYS LTD

1 NEW ROAD, CROYDON CR0 1DP

DAMP SURVEY REPORT

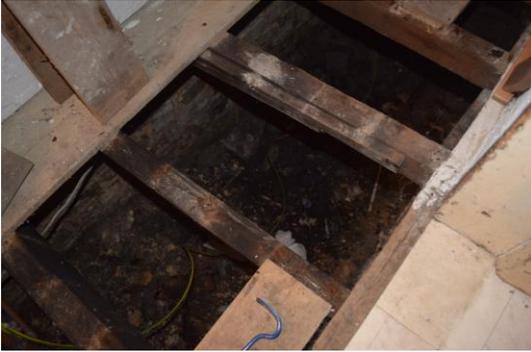
Photograph 1: Access made to access under floor void.

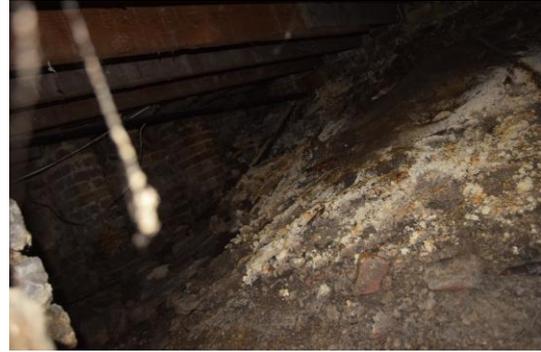
Photograph 2: General view of front floor void with excessive rubble.

5. Improved floor void ventilation. Floor cross ventilation can be improved by reducing the amount of rubble in the void and replacing isolated bricks with air bricks in the rear elevation (1no. additional) and in the load bearing walls under the floor (4no. required).

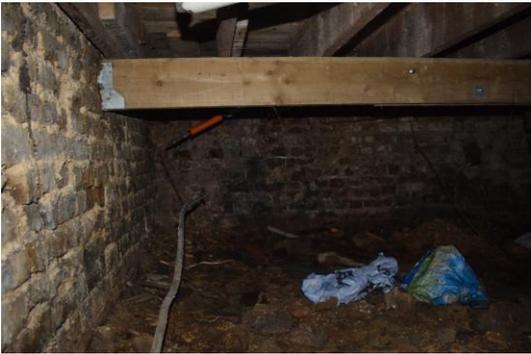
Photograph 3: General view of rear void, sump located to the rear of the blue bag.

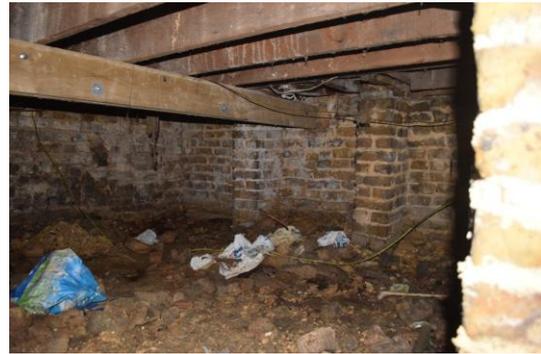
Photograph 4: General view of rear void, sump located to the rear of the blue bag.

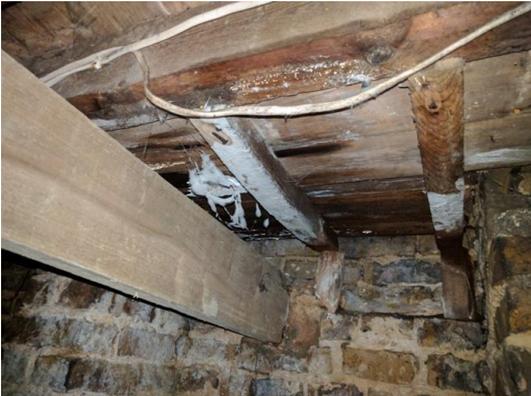
The water had caused consequential damage, especially to the rear section of the property floor all the timbers were saturated meaning that damp and decay was inevitable. We saw a large section of dry rot fruiting body to the rear section of the kitchen it is likely that 70% of the kitchen floor will have to be replaced. This will extend to all of the timber underneath the stairs. You must allow for all effected rotten wood to be removed beyond 1m of the affected area. Remaining timber will need to be treated by a specialist.

Photograph 5: Dry rot effected timbers.

6. New chemical injection damp proof course to the perimeter the building especially the internal walls if items 1,2, 3 and 4 have been completed.
7. Dry Rot infestation. Once the leak has been resolved the dry rot infestation will need to be cut out and removed extending beyond 1m of the last effected section. Specialist timber treatment company should then treat the remaining timber of that element.

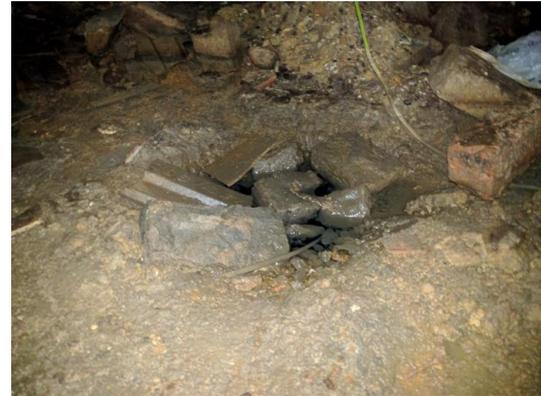
Photograph 6: Close up of sump void.
